STRUCTURAL RESPONSE MONITORING OF NEW ZEALAND BRIDGES

Jeremy Waldin^{1,*}, Chloe McKenzie¹, Jeremy Jennings¹ and Russell Kean^{2,**}

¹ Opus International Consultants Limited, Christchurch Bridge and Civil Structures Team, 20 Moorhouse Avenue, PO Box 1482, Christchurch, New Zealand. *Email: jeremy.waldin@opus.co.nz

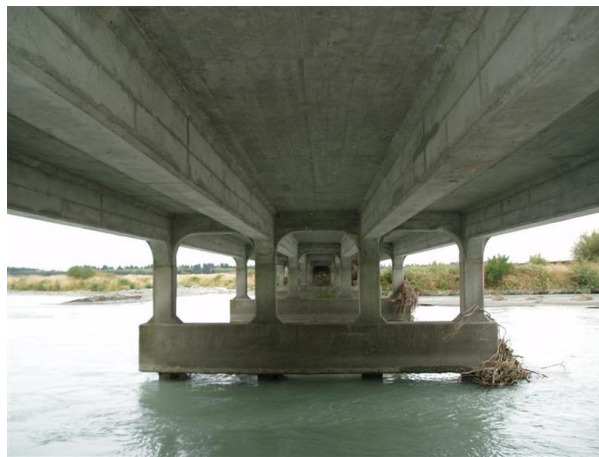
Figure 1 View of SH1S Rakaia River Bridge beams, superstructure and piers

The Rakaia River and Rangitata River No.1 and No.2 Bridges are located on State Highway 1S (SH1S) within the South Island of New Zealand, just north of Rakaia township, and approximately 35km south of Ashburton township respectively. All three bridges were constructed between 1939 and 1940, and comprise of conventional two lane reinforced concrete bridges, with essentially identical superstructures. The superstructures consist of four reinforced concrete T-beams, supported on reinforced concrete columns and pile caps, founded on driven reinforced concrete piles, as illustrated in Figure 1 below.

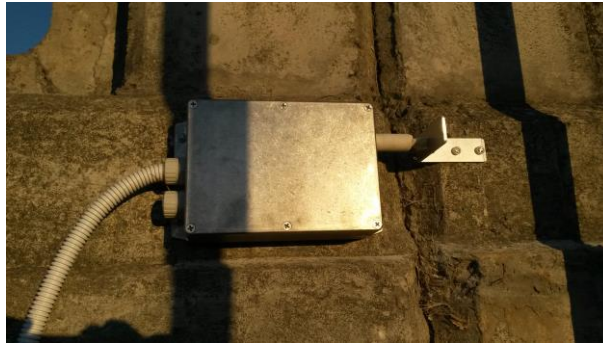
Figure 9: Permanent displacement transducer installed to monitor beam/column joint opening

Permanent joint monitoring using displacement transducers has now been installed on both of the Rangitata River Bridges (as shown in Figure 9), with data transmitted via solar powered data loggers to the Opus network. If this monitoring is successful, this can be cost effectively extended to incorporate additional vulnerable spans. Joint damage will be monitored by separating peak joint displacements into ‘bands’. Site inspections will be triggered if the frequency of peak joint displacements increases out of proportion with the heavy vehicle movements. Trigger levels will also be set if the joint displacement is above critical thresholds, or if the frequency of joint displacement decreases, as this would be a sign that damage has occurred in the beam away from the joint. Overall thermal variations are being filtered out of the overall data when assessing vehicle displacements.
